# Helium Leak Detection on **PLASTIC OPHTHALMIC CONTAINERS**

## CHALLENGE

## HELIUM LEAK TESTING EVALUATION

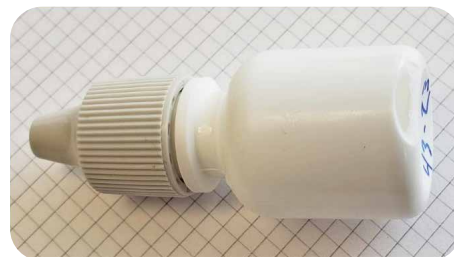
- Pressing the nozzle tip into the bottle neck.
- Applying the closure to a specified torque (4.0 – 4.5 lbf-in.)
- Creating a small hole in the bottle base (to allow helium gas to fill the bottle interior during the test cycle).

Sample Test Container

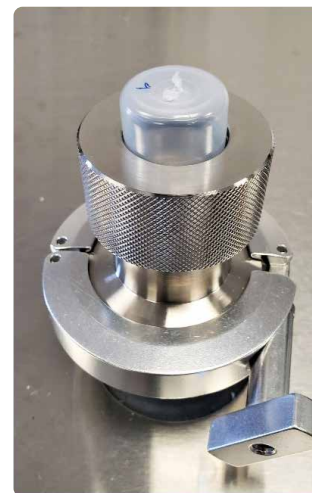
- Placing the Closure/Neck of the bottle package into a custom vacuum chamber fixture, inverted. This fixture would allow only the exterior area below the shoulder to be subjected to the vacuum pressure of the helium leak detector (HLD).
- Once a vacuum cycle reached fine test mode, the test sample was allowed to stabilize for approximately 15 seconds.
- With a stable background leak rate, helium gas flowed to the interior of the bottle through a syringe/flowmeter device. The flow remained constant for approximately 10 seconds.
- Final leak rate data was collected 30 seconds after reaching fine test mode on the HLD.

Bottle Vacuum test fixture with closure/neck under vacuum pressure
