# Helium Leak Detection with Plastic Containers

## Introduction:

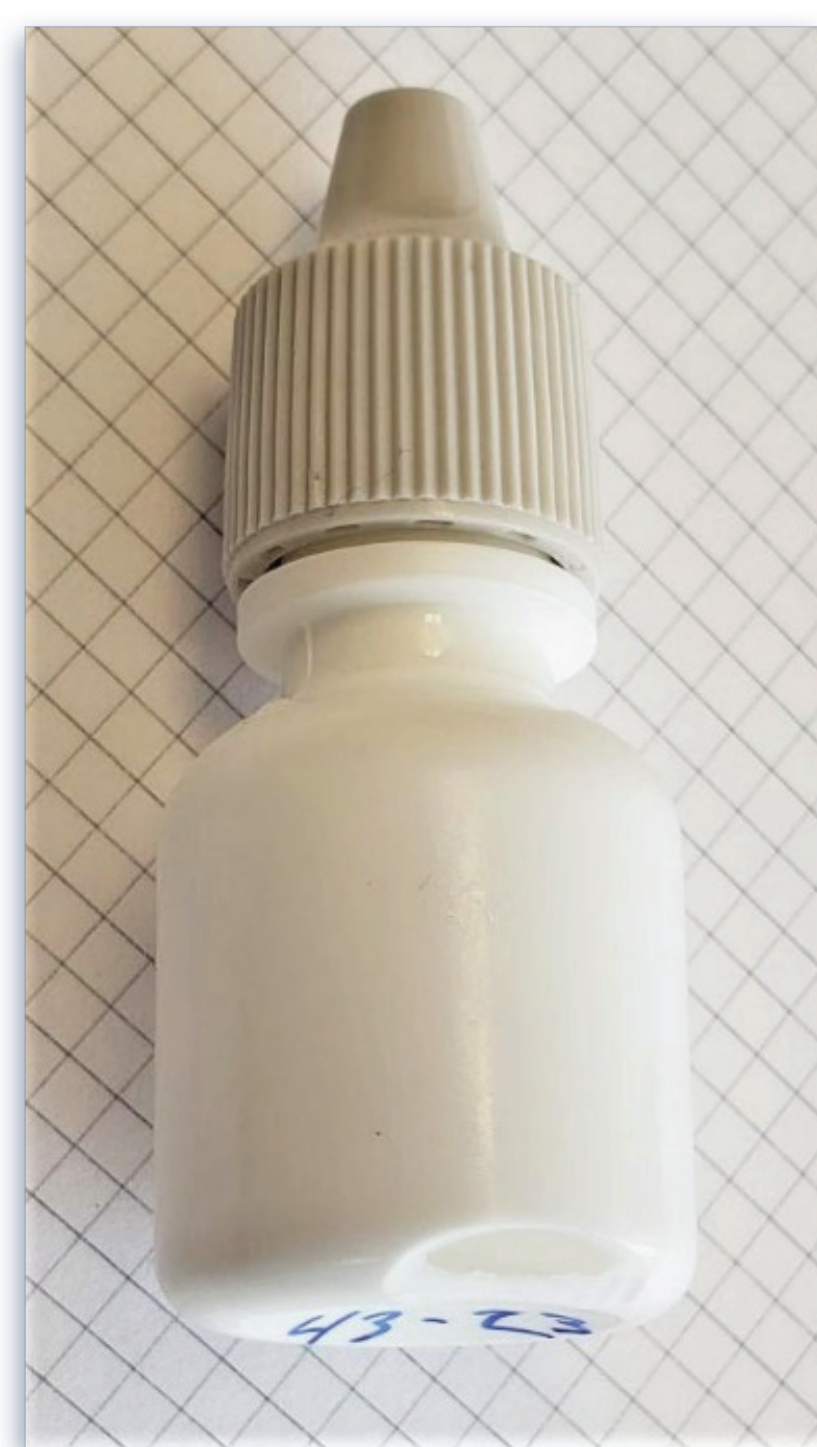
Sample Test Container

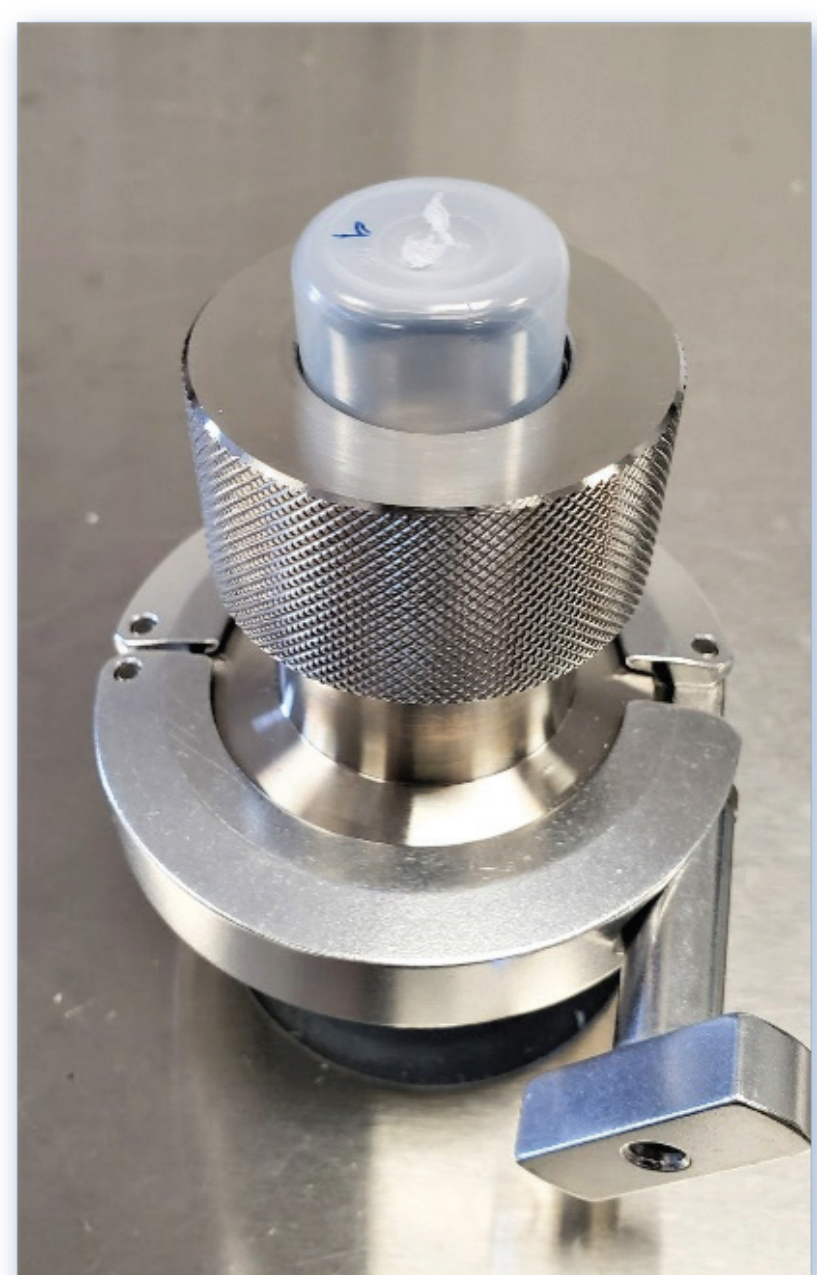
Container Vacuum Chamber Fixture

- The Closure/Neck of the bottle package was placed into a custom vacuum chamber fixture. This fixture would allow only the exterior area below the shoulder to be subjected to the vacuum pressure of the helium leak detector (HLD).
- Once a vacuum cycle reached fine test mode, the test sample was allowed to stabilize for approximately 15 seconds.
- With a stable background leak rate, helium gas flowed to the interior of the bottle through a syringe/flowmeter device. The flow remained constant for approximately 10 seconds.
- Final leak rate data was collected 30 seconds after reaching the fine test mode on the HLD unit.
